# **THIELSCH ENGINEERING, INC.**

Subject: Ultrasonic Nondestructive examinations and evaluation of Cooling Piping at Tremont Street Boston MA. TEI Project Number 40-11-0130

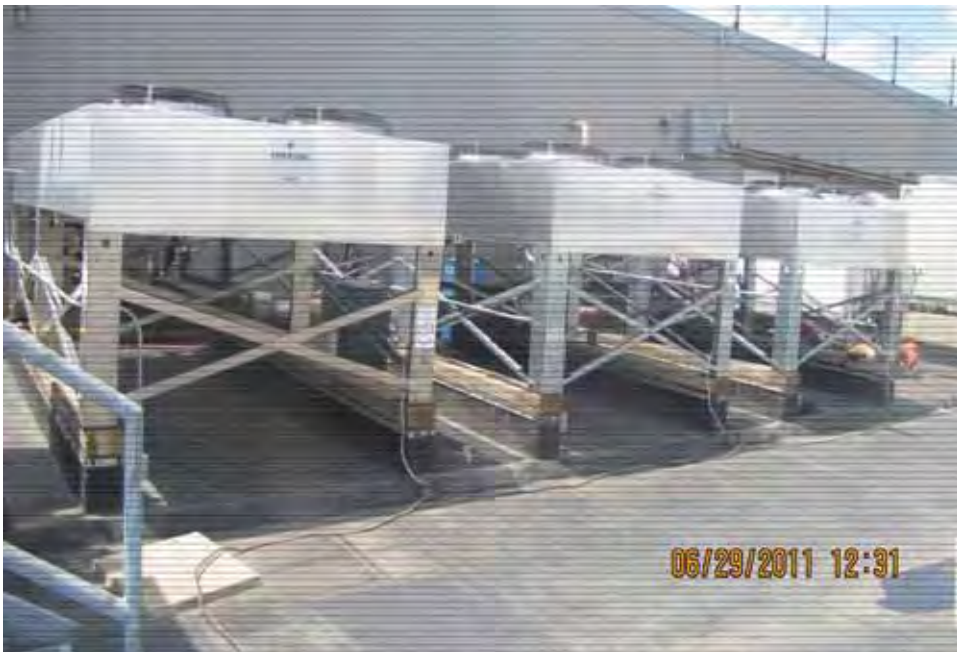
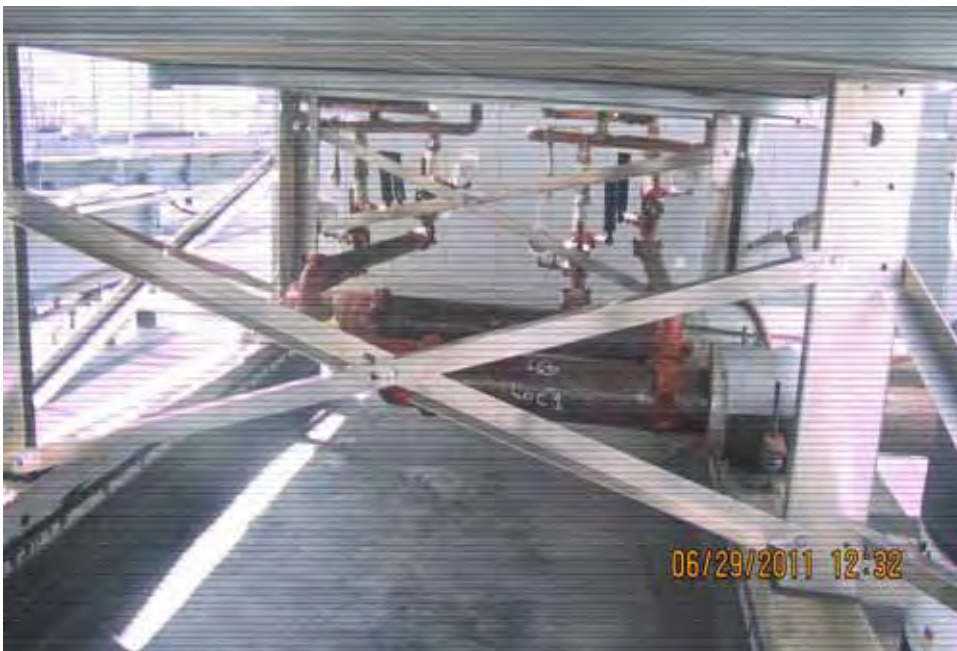
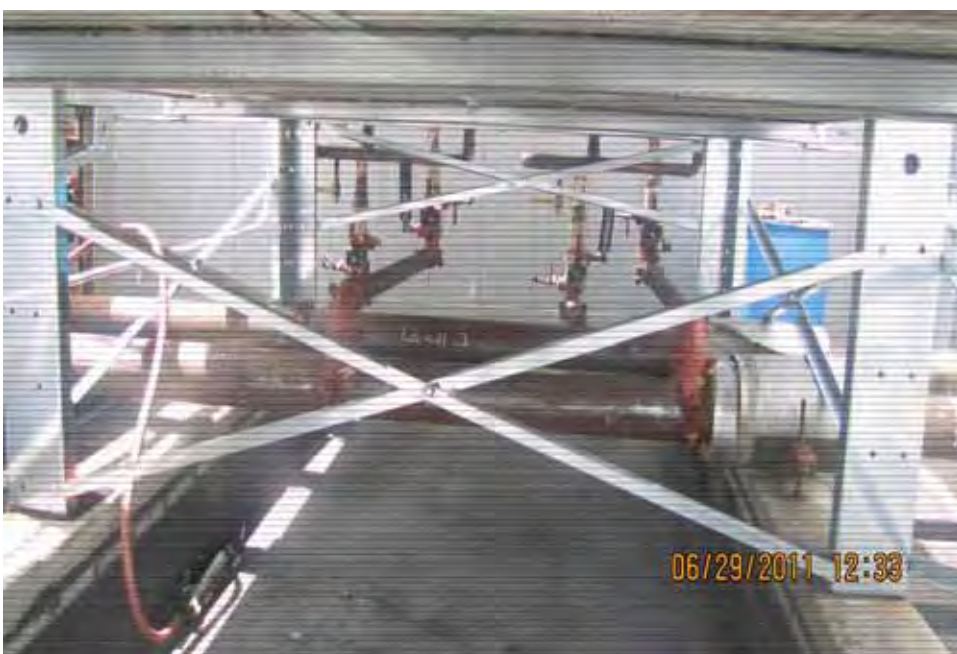
Fig. 1.

The visual examination of the selected glycol piping locations were revealed to be in good overall condition other than minor rusting. The visual examination did not reveal any significant service related deterioration of the exposed locations of the supply and return pipes.

Overall photographs of the glycol piping.

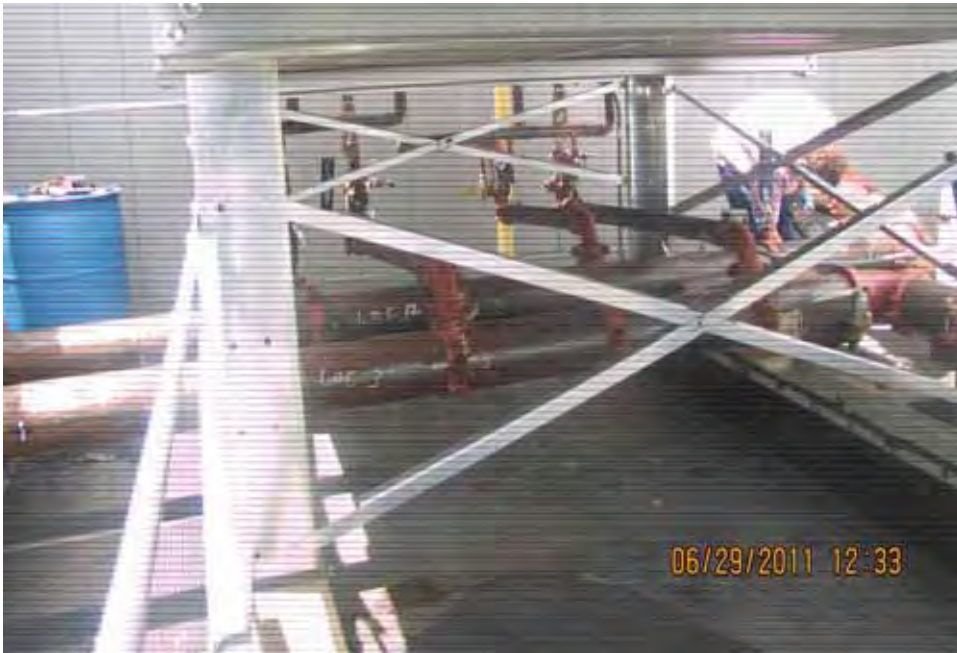
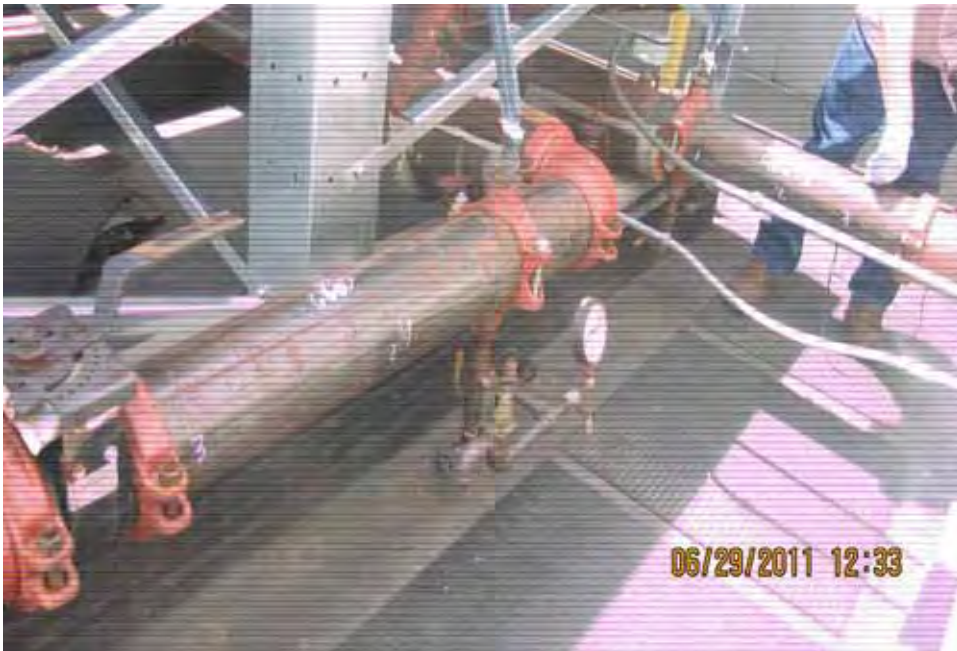
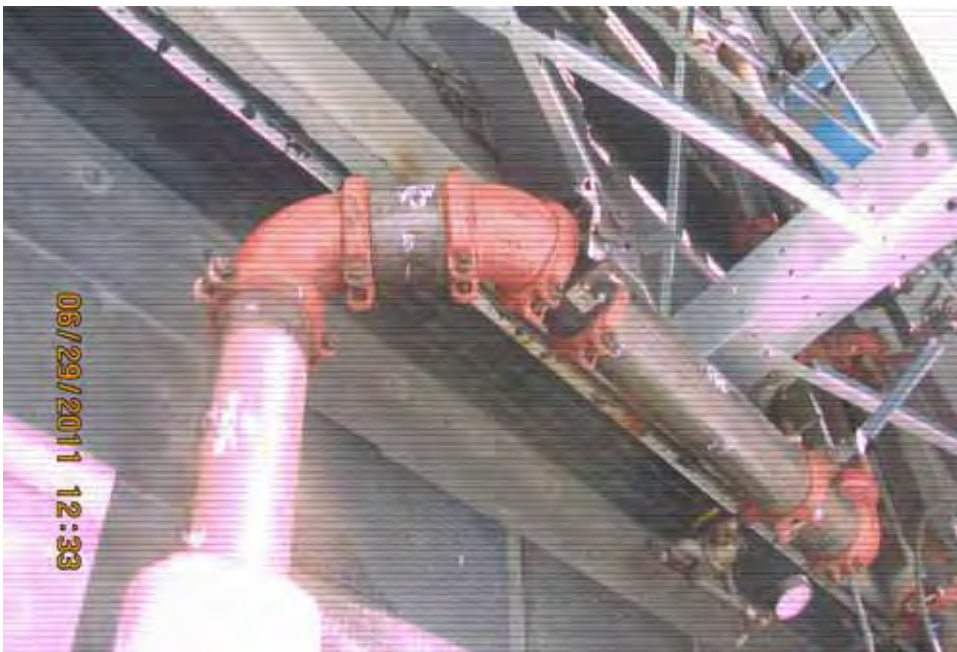
Fig. 2.  
Overall views typical of the inspected locations of the glycol piping.

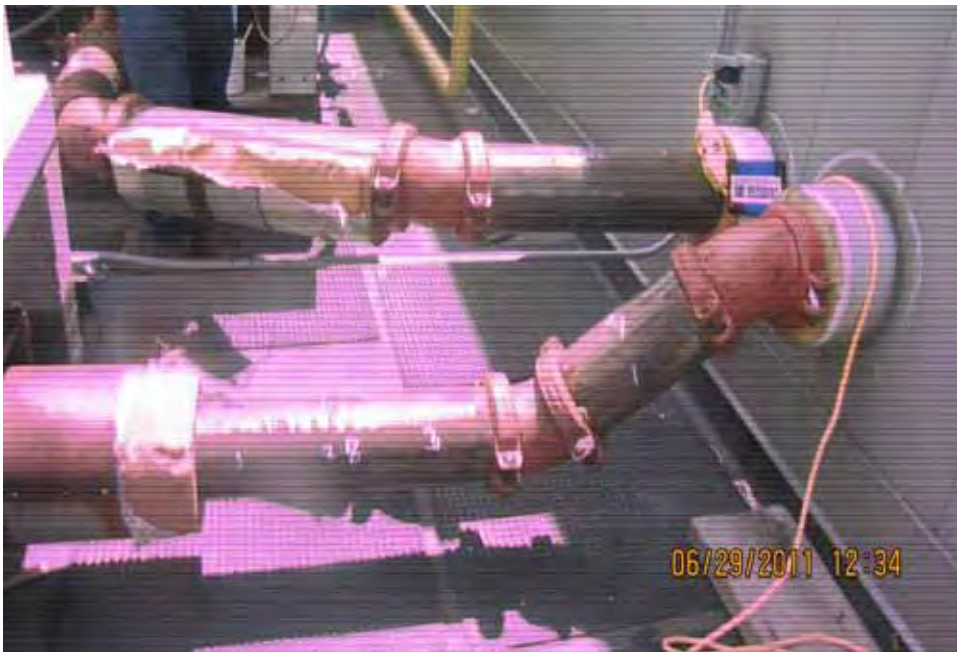
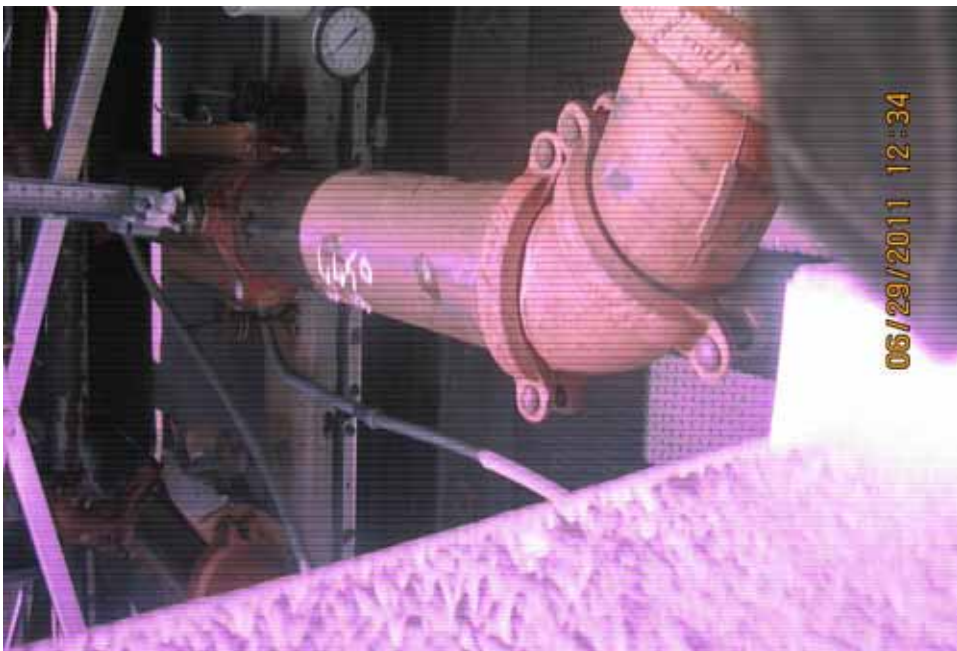
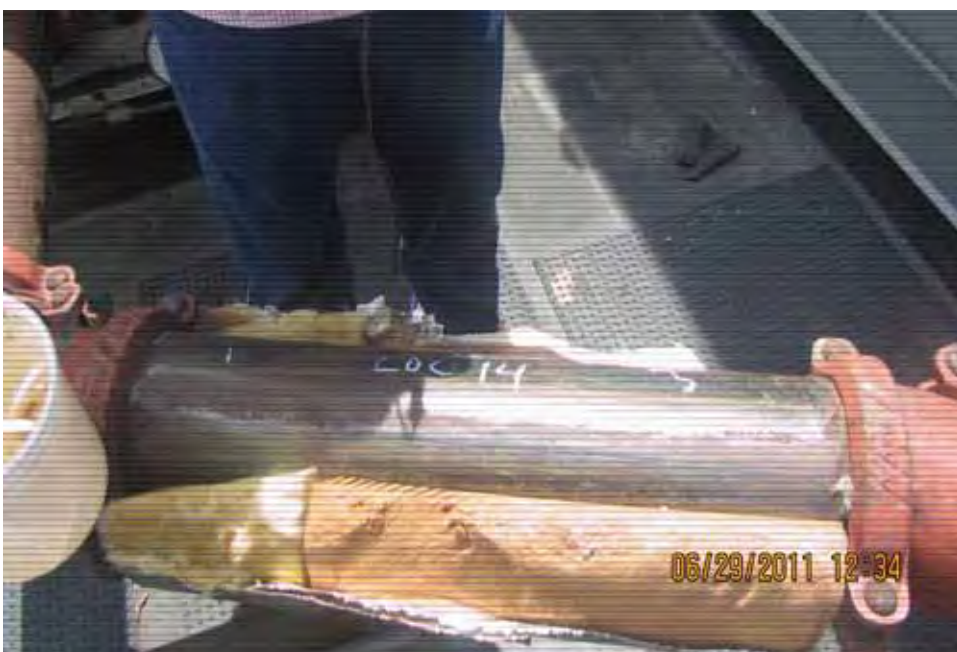
Fig. 3.

Overall views typical of the inspected locations of the glycol piping.

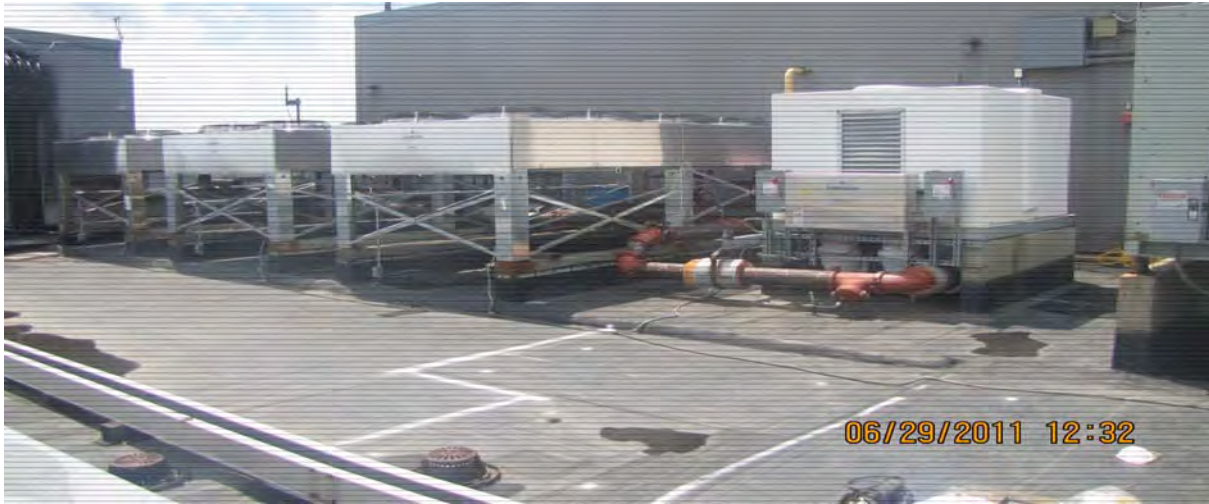
## COOLING PIPING

Ultrasonic thickness examinations were performed at each exposed section of NPS 6 and at random locations of the NPS 2 1/2 piping. Measurements were recorded at four corner points around the pipe (12:00, 3:00, 6:00 and 9:00 o'clock positions) at the selected areas. The ultrasonic thickness measurements were consistent for schedule 10 piping on both the NPS 6 and NPS 2 1/2 glycol piping. It was originally believed from information obtained for the customer that the glycol piping was schedule 40, however the ultrasonic measurements were not consistent with that information. Several locations were revealed with one or more recorded value below the nominal thickness for sch. 10 piping. When compared to the nominal wall thickness for each section, none of the measurements were below the estimated nominal wall thickness by more than 6%.

Attached to this report is a sketch showing the locations examined and the thickness data along with the diametric measurements recorded for the glycol piping. The results of the examinations are also provided is detailed in the nondestructive examination report in Appendix A.

Based upon the results of the various examinations, the glycol piping on the roof is consistent with NPS 6 sch 10 and NPS 2 1/2 sch 10. It is recommended that a similar inspection be completed after three years of continued service in order to identify an average corrosion rate of the pipes.
