# **THIELSCH ENGINEERING, INC.**

Subject: Ultrasonic Nondestructive examinations and evaluation of Cooling Piping at Tremont Street Boston MA. TEI Project Number 40-11-0130

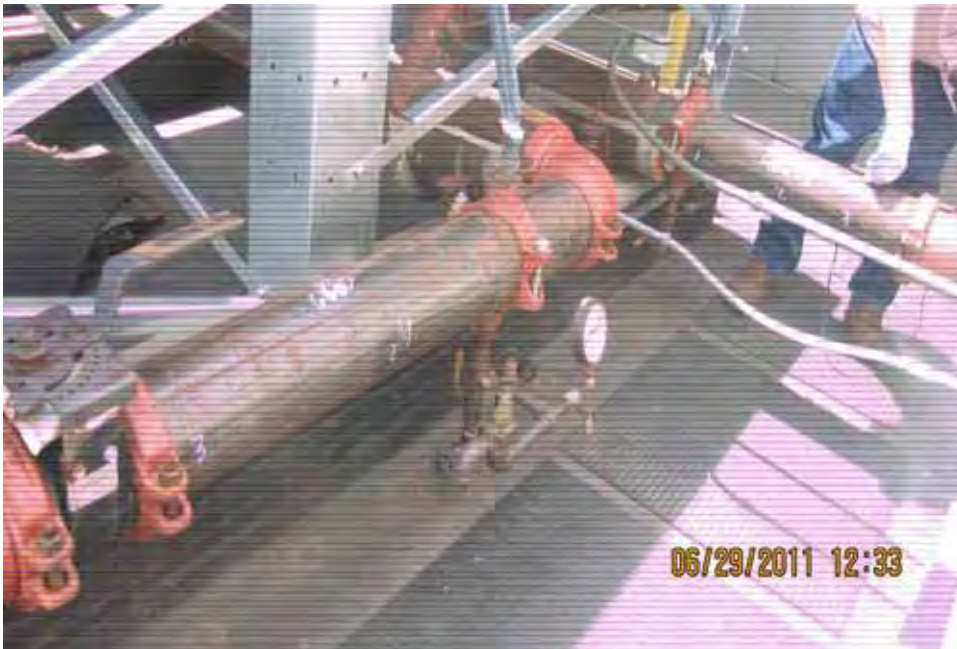
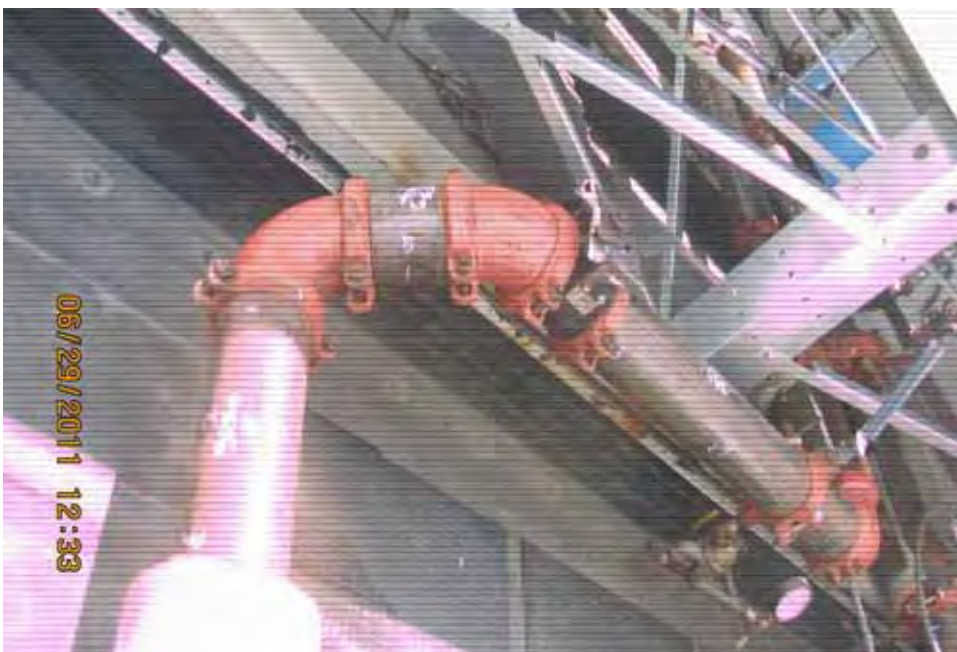
Fig. 2.

Overall views typical of the inspected locations of the glycol piping.

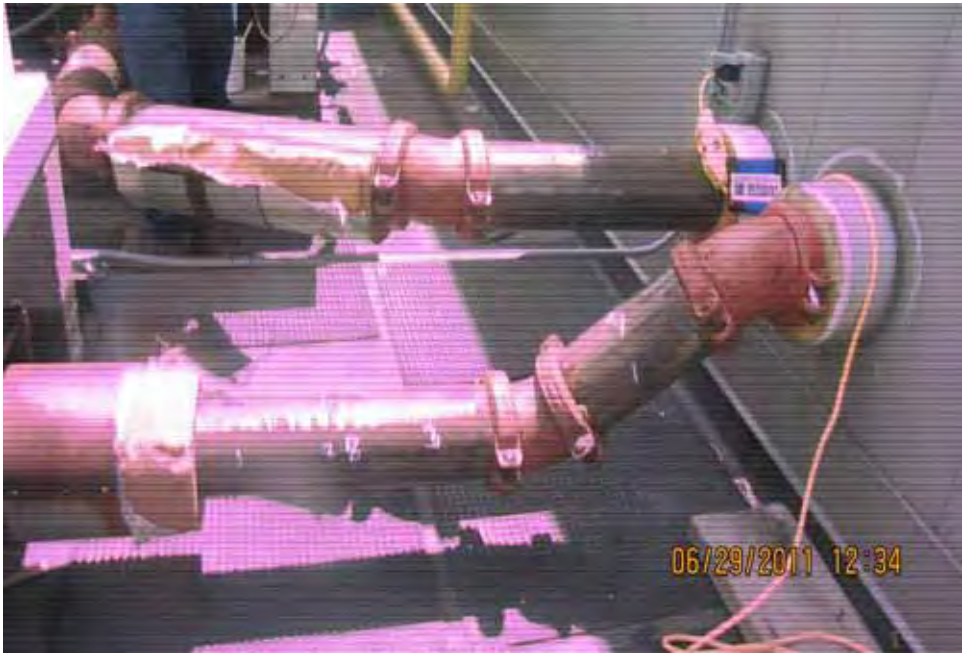
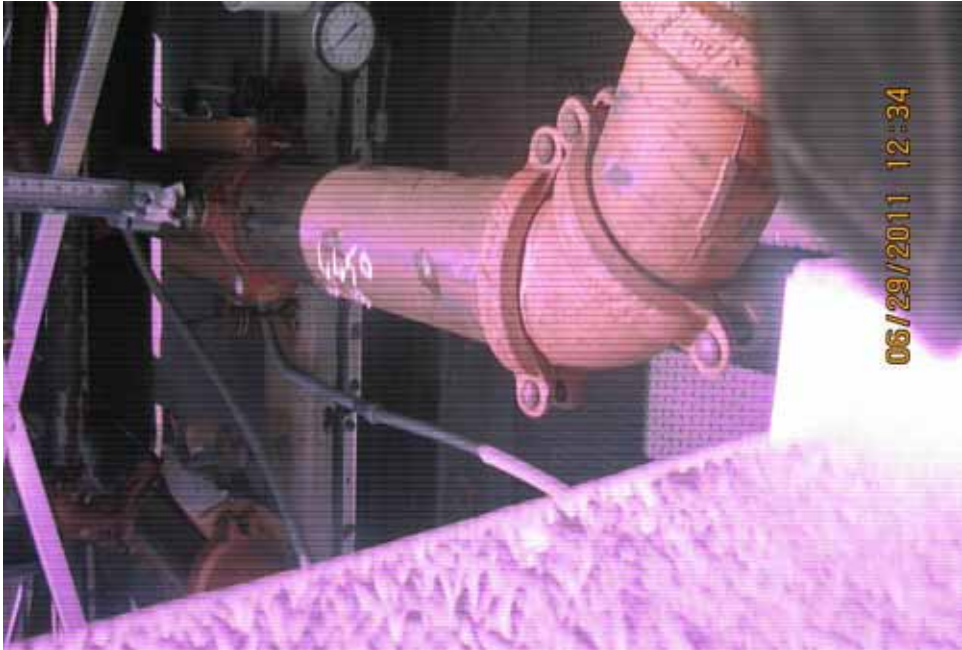
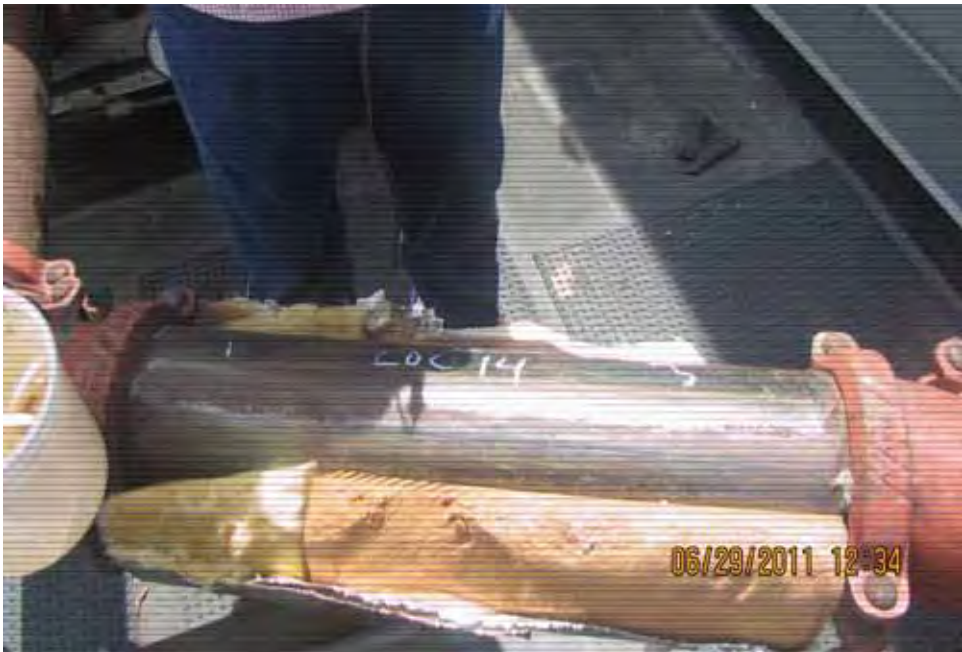
Fig. 3.

Overall views typical of the inspected locations of the glycol piping.
